THE INSPECTION KINGDOM LLC

## INFRARED SCAN REPORT

1234 Main Street  
Houston, TX 77068

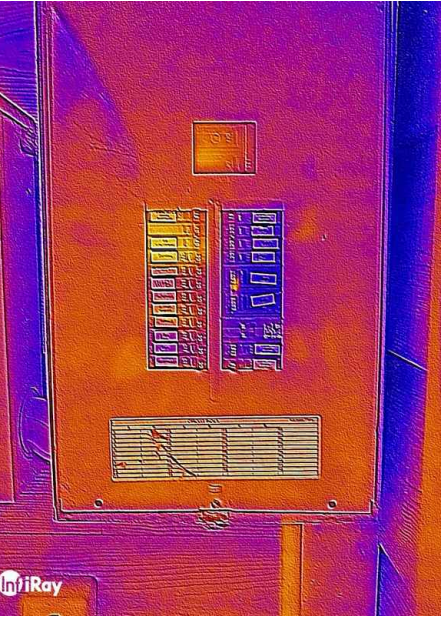
**Electrical System: Thermal  
Anomalies Observed**

No

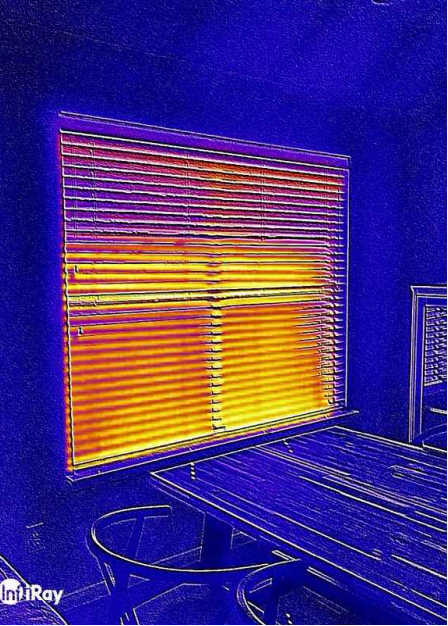
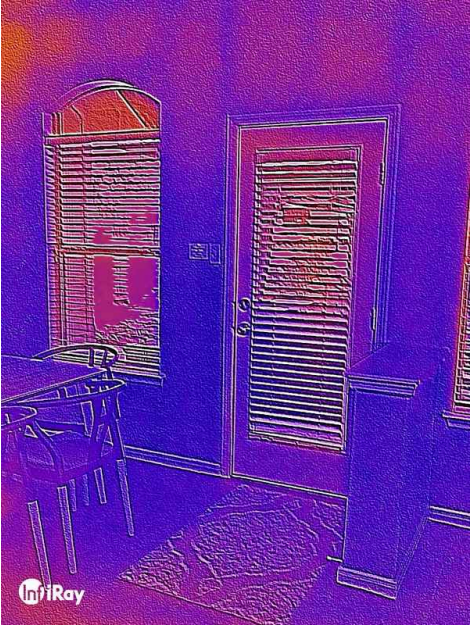
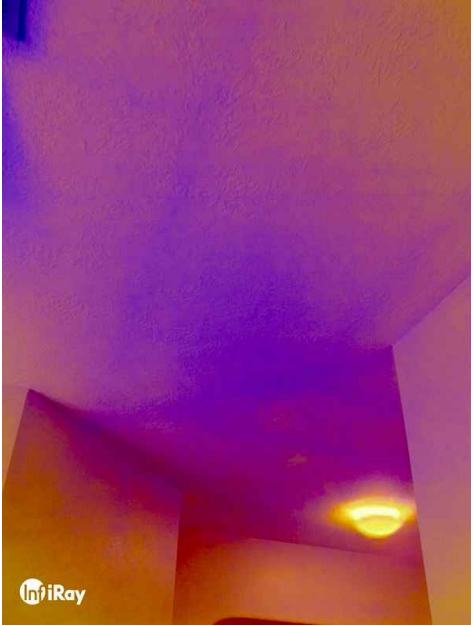
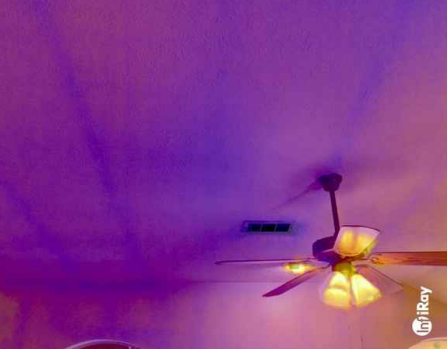
Ceilings & Interior Walls: Thermal Anomalies Observed

No

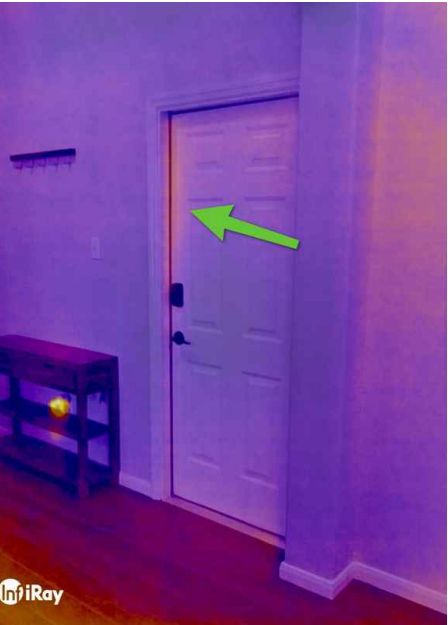
Doors & Windows: Thermal Anomalies Observed

Yes

Air Infiltration

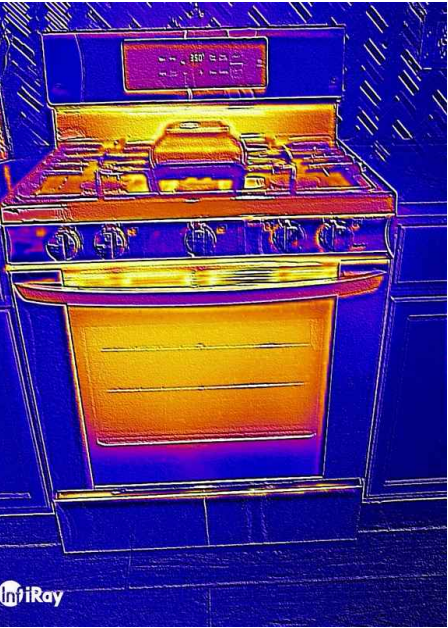
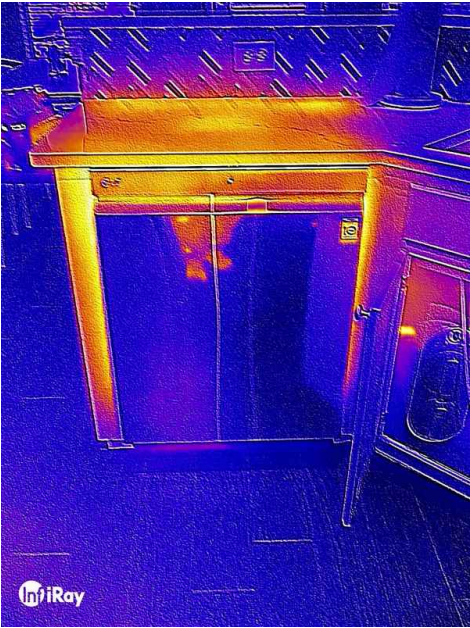
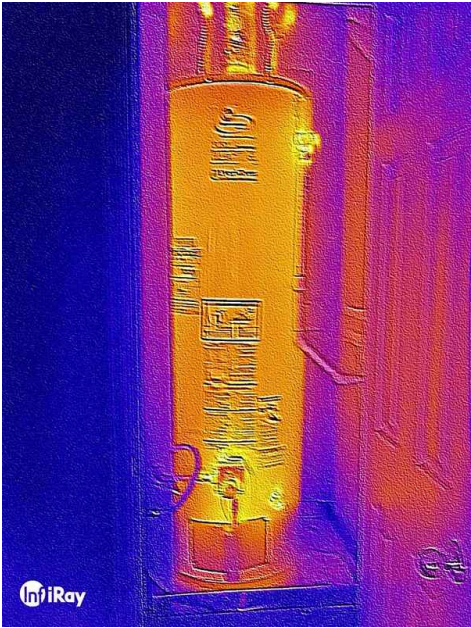
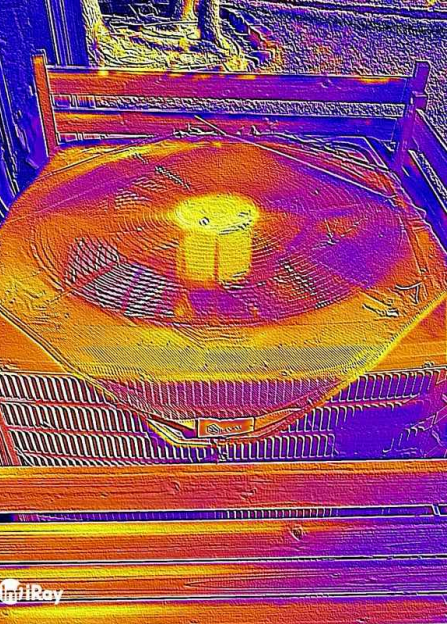
Appliances: Thermal Anomalies Observed

No

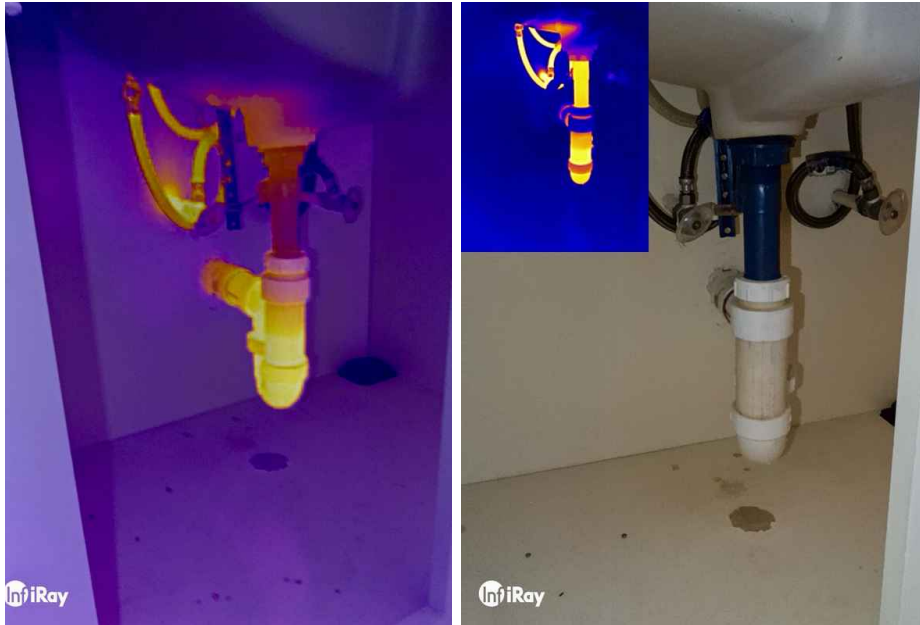
## Drain System: Thermal Anomalies Observed

No

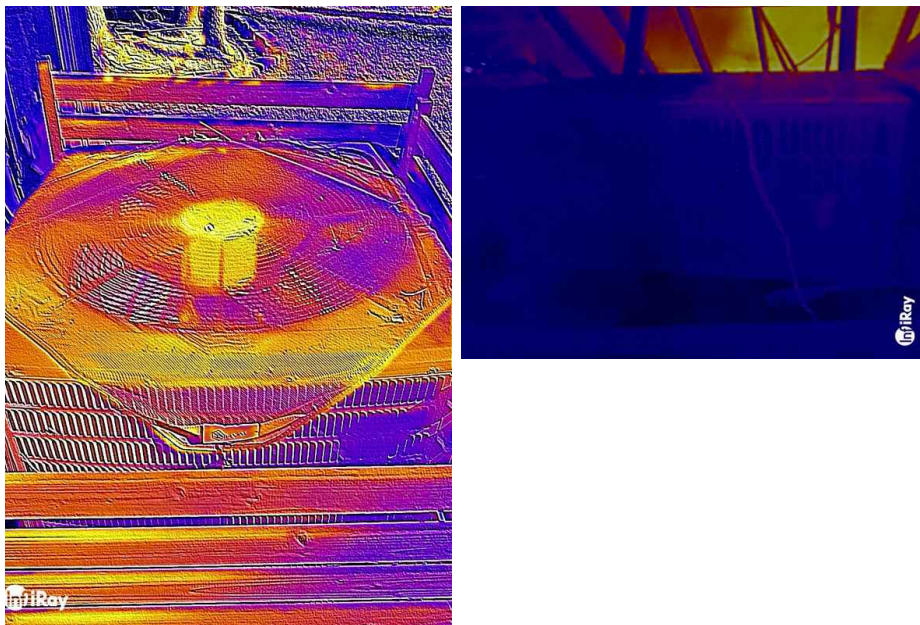
## HVAC System: Thermal Anomalies Observed

No
