## T.R.E.C. STANDARD HOME INSPECTION REPORT

1234 Main Street  
Houston TX 77068

07/02/2026 9:00AM

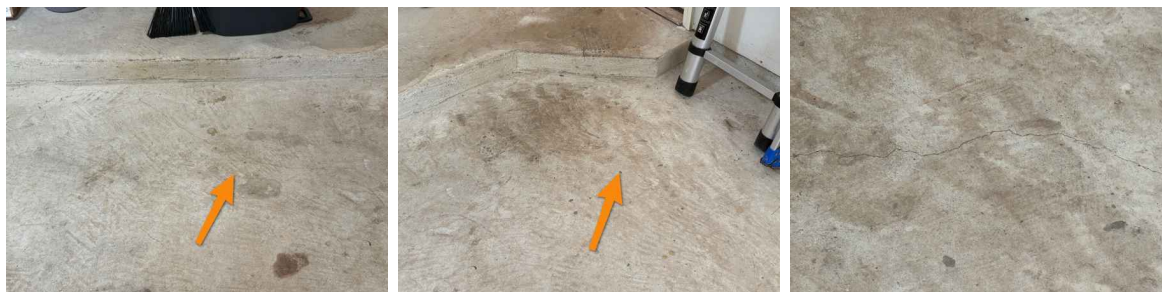
There are shrinkage cracks in the garage floor. These cracks are typical, however we do recommend that you seal and monitor these cracks for further movement over time.

Recommendation: Contact a qualified professional.

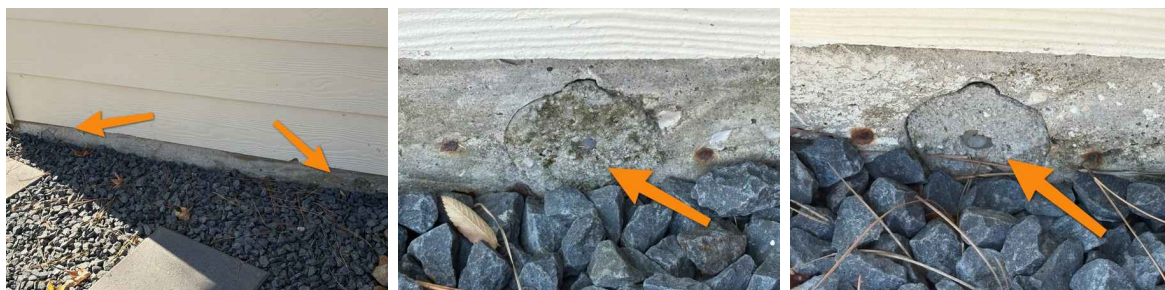
## 2: Post Tension Slab - Cable Ends Are Exposed

One or more of the post tension cable ends are exposed and need to be properly sealed to prevent deterioration/corrosion of the cable at one or more areas of the structure.

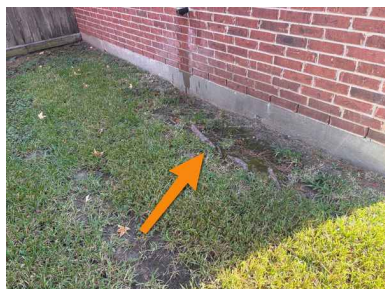
Left Side

Roots were observed near foundation wall. Unable to determine if the roots have any effect on the home. Recommend monitoring.

Recommendation: Contact a qualified professional.

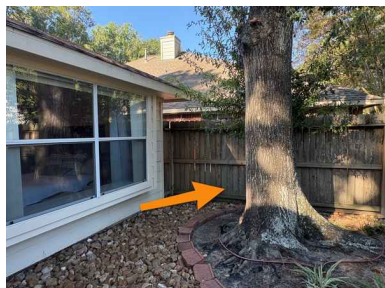
Rear Of Home

Observed tree roots within 10 feet of the home. Unable to determine if the root system have any affect on the homes foundation.

Recommendation: Contact a qualified professional.

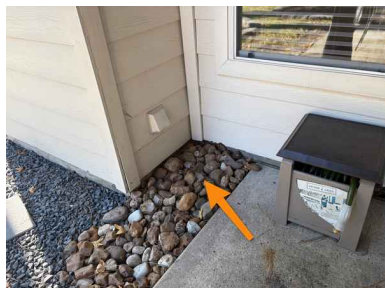
Rear Of Home

The soil/mulch levels were high against isolated areas of the foundation grade beam. When soil or mulch levels and vegetation are high against the face of the foundation it promotes water penetration, wood rot and insect infestation. Brick veneer wall cladding should have about 4" of clearance between the soil/mulch and the first course of bricks, and other materials should have 6" of clearance between other materials and the soil/mulch. When siding is installed directly on the ground it is important to note that inspectors cannot see the foundation grade beam and there is more of a chance for water to enter the home in times of heavy rains. It is very important to check with the Owner to make sure there has not been flooding into the home.

Recommendation: Contact a qualified professional.

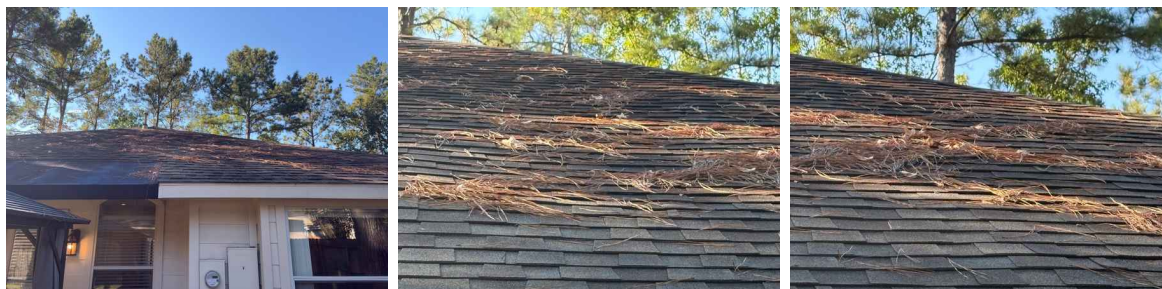
Debris was observed on the roof covering materials during the inspection. This accumulation can potentially trap moisture and accelerate roof material degradation. Regular roof cleaning and maintenance is recommended to prevent potential long-term damage and extend the roof's service life.

Recommendation: Contact a handyman or DIY project

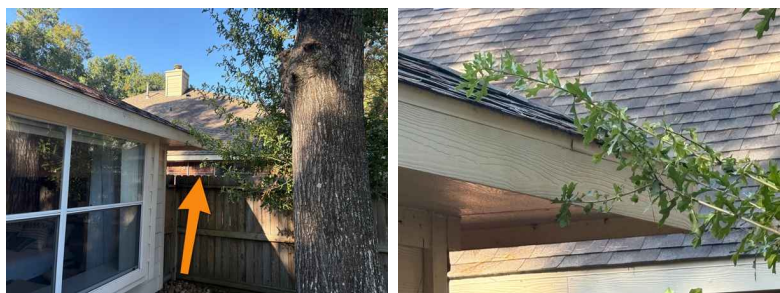
Tree branches impinging roof line can damage a roof even in a gentle breeze. Whenever a tree is in contact with the roof structure, we recommend trimming the tree or branches back aggressively.

Recommendation: Contact a qualified tree service company.

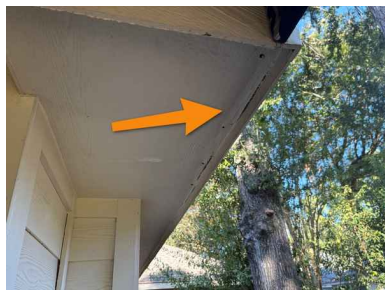
Rear Of Home

The soffit of this home is in need of sealing and or paint.

Recommendation: Contact a qualified painting contractor.

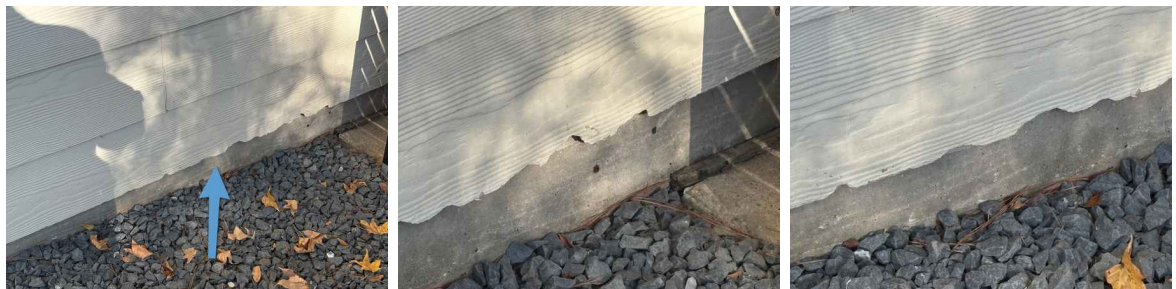
Backyard Right Side

Fiber cement siding shows visible damage during the property inspection. This type of damage can compromise the exterior protective barrier of the home, potentially allowing moisture intrusion and creating vulnerabilities in the building envelope.

Recommendation: Contact a qualified carpenter.

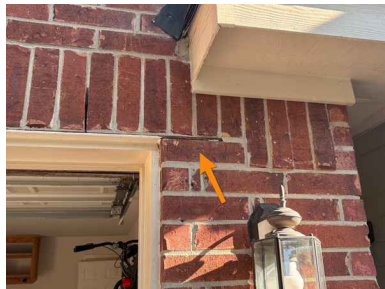
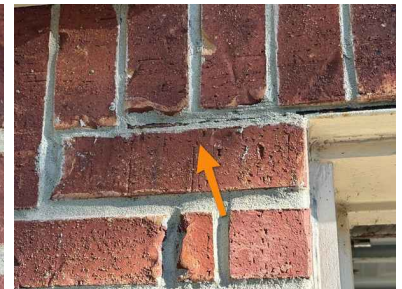
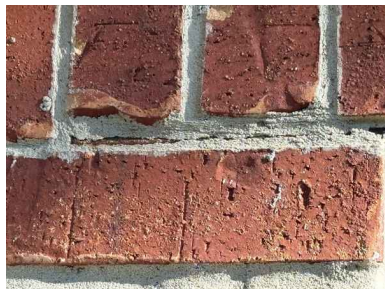
## 2: Lintel over garage door is in need of sealing

There is some movement in this area which is to be expected over an opening like a garage door. We recommend that you monitor this area for sagging in the future.

Recommendation: Recommend monitoring.

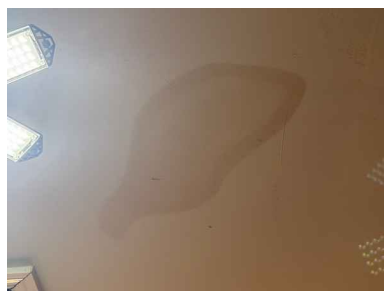
Garage

There is moisture staining on the ceiling we recommend that this be monitored to see if there are any ongoing issues in these areas.

Recommendation: Contact a qualified professional.

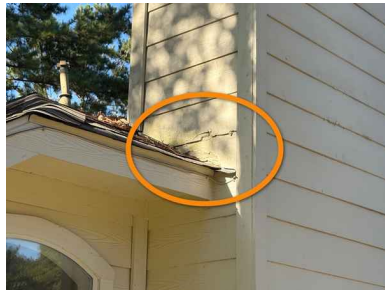
The chimney siding shows visible damage, including cracked and missing sections, which appear consistent with storm-related impact, such as high winds or flying debris. This damage may compromise the chimney's weather resistance, potentially allowing water infiltration and further deterioration if not promptly repaired.

Recommendation: Contact a qualified chimney contractor.

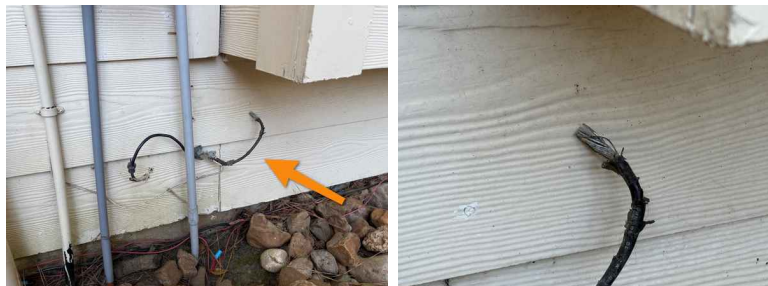
The grounding wire is not attached to the grounding rod. Recommend repair.

Recommendation: Contact a qualified professional.

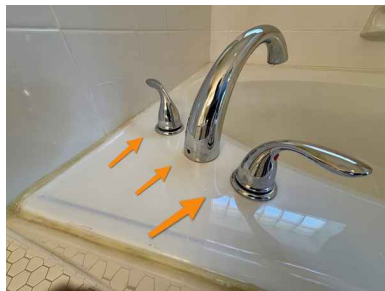
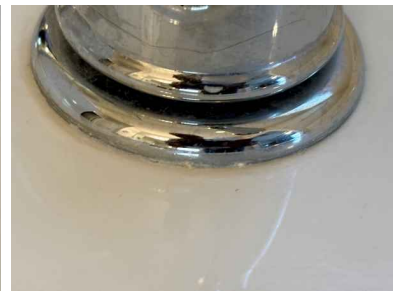
The caulking around the sink(s) is/are in need of repair

Recommendation: Contact a handyman or DIY project

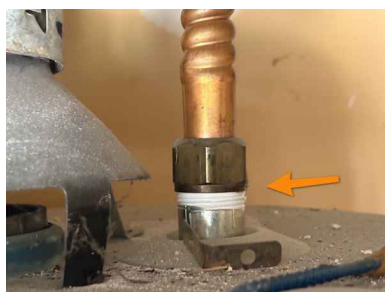
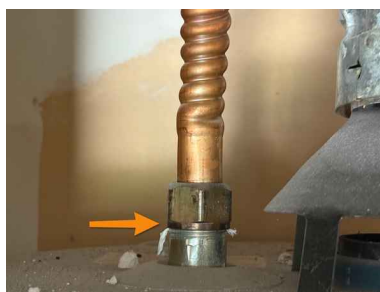
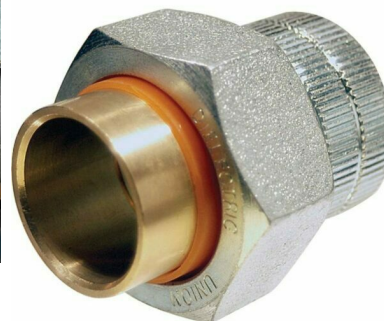
**Dielectric unions** are typically installed at the connection points between the water heater and the water supply pipes. Their purpose is to separate dissimilar metals, such as copper and steel, which are commonly found in water heaters and plumbing systems. This separation helps to prevent galvanic corrosion, which can lead to leaks and premature failure of the water heater and associated pipes.

Recommendation: Contact a qualified plumbing contractor.

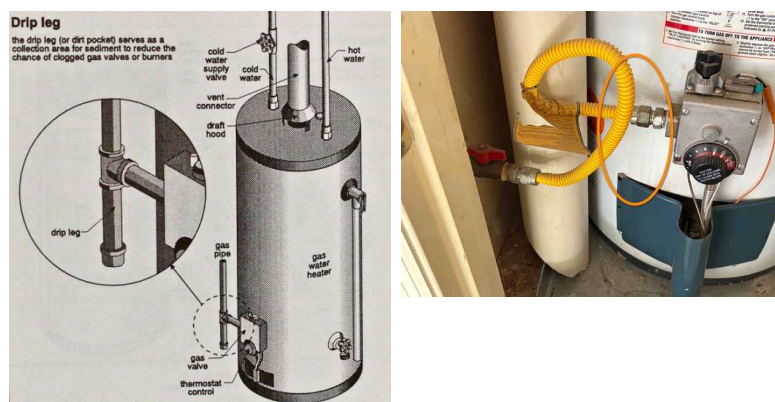
### 2: Missing Sediment Trap

The sediment trap shall be either a tee fitting having a capped nipple of any length installed vertically in the bottommost opening of the tee as illustrated in Figure G2419.4 or other device approved as an effective sediment trap. Illuminating appliances, ranges, clothes dryers, decorative vented appliances for installation in vented fireplaces, gas fireplaces, and outdoor grills need not be so equipped.

Recommendation: Contact a qualified plumbing contractor.

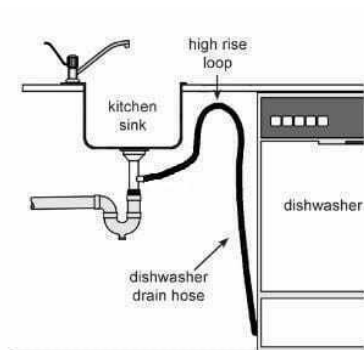
#### 1: Highloop needed

Recommendation: Contact a handyman or DIY project
