## POOL & SPA INSPECTION REPORT

1234 Main Street  
Houston, TX 77068

07/02/2026 9:00AM

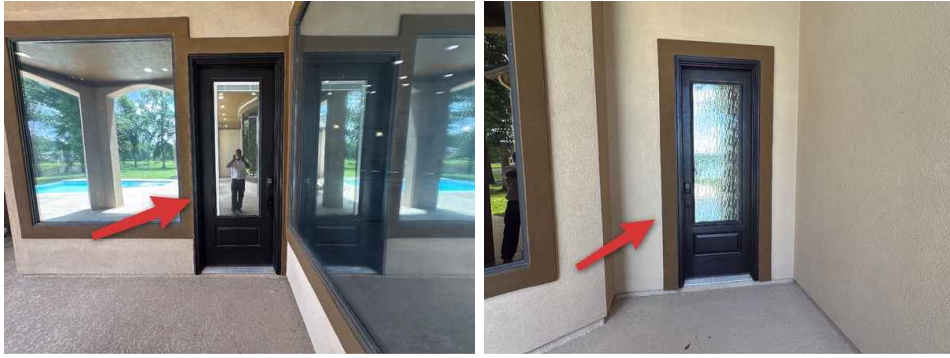
1.1.1 Safety Devices:

### DOOR ALARMS ARE NOT INSTALLED.

All doors that lead to the pool area should be protected with door alarms unless separate pool fencing is installed.

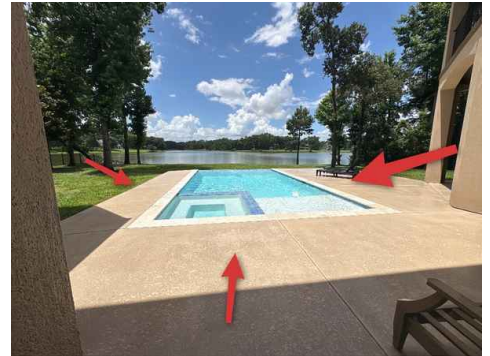
## 1.1.2 Safety Devices:

**NO POOL FENCING**

No separate pool area fencing was installed at this time. It is recommended to have proper fencing with proper gates and latches installed.

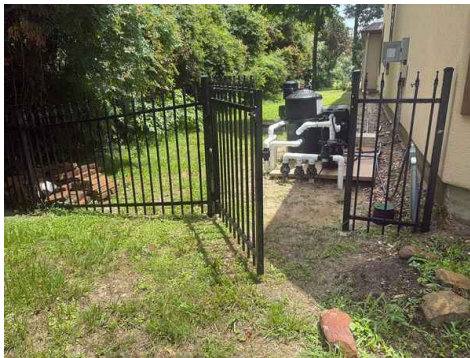
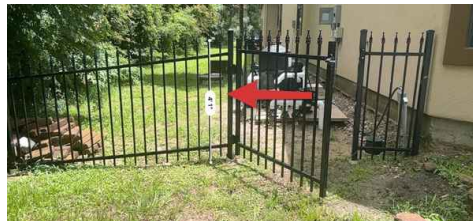
## 1.1.3 Safety Devices:

**PERIMETER GATES DO NOT COMPLY WITH BARRIER REQUIREMENT.**

All the perimeter gates that provide access to the pool/spa area should be self-closing and self-latching and open away from the pool area and the latch needs to be 52 inches off the ground. It is recommended to have them repaired.

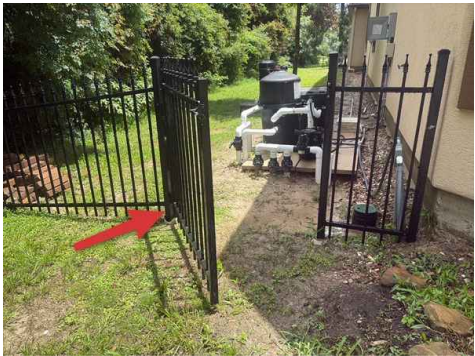
## 1.1.4 Safety Devices:

**SELF-CLOSING HINGES NOT FUNCTIONING AS INTENDED**

Observed that the self-closing hinges on the gate(s) securing the swimming pool area are not functioning as intended. After each use, the gate does not fully close, compromising the safety measures required by TREC and IRC. It is recommended to promptly address and repair the self-closing mechanism to ensure the gate consistently closes securely, meeting safety standards.

Recommendation  
Contact a handyman or DIY project

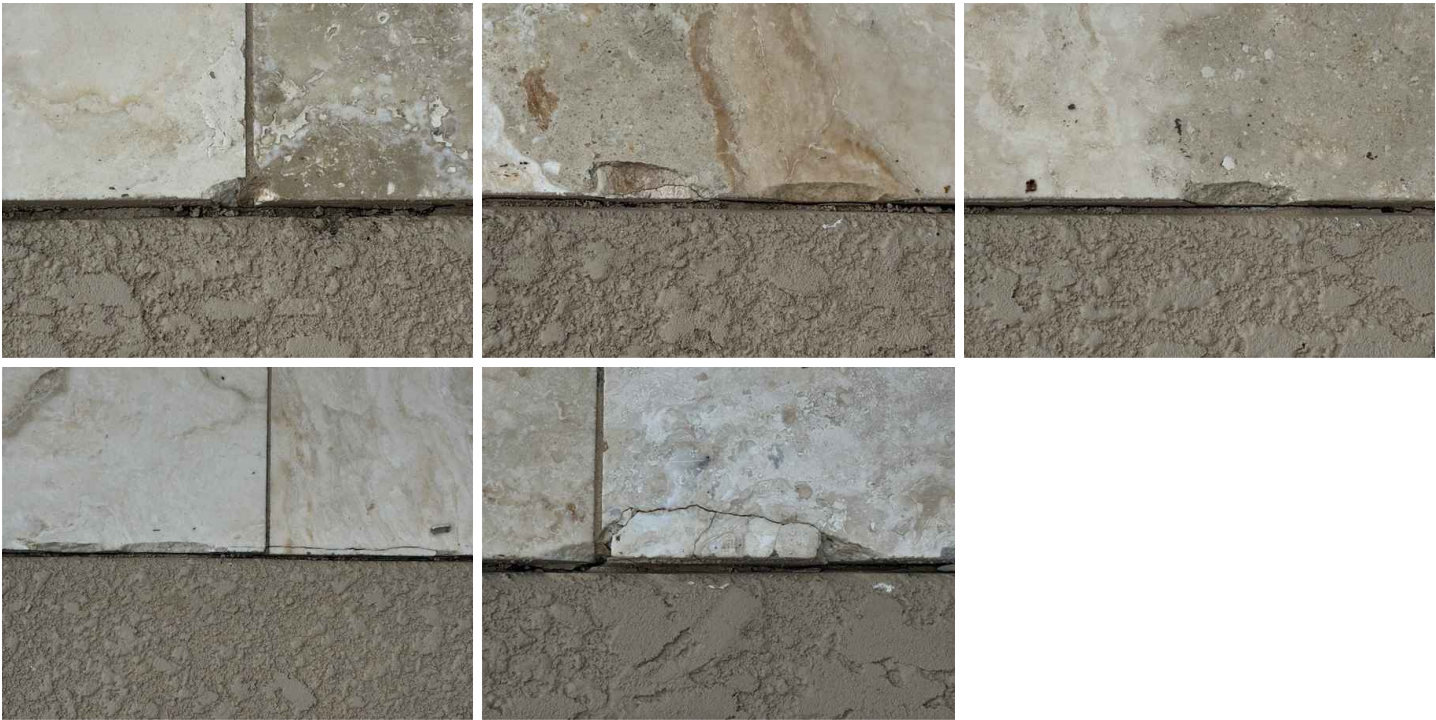
1.2.1 Pool Area Coping, Tile and Decking:

**CHIPPED AND SPALLING STONE COPING**

Chipping and spalling observed on the stone coping around the pool area. This deterioration exposes the underlying material to further water infiltration and freeze-thaw damage, which accelerates degradation. The compromised coping may also create sharp edges that pose a safety hazard to swimmers. A pool contractor should evaluate the extent of damage and recommend repair or replacement of affected sections.

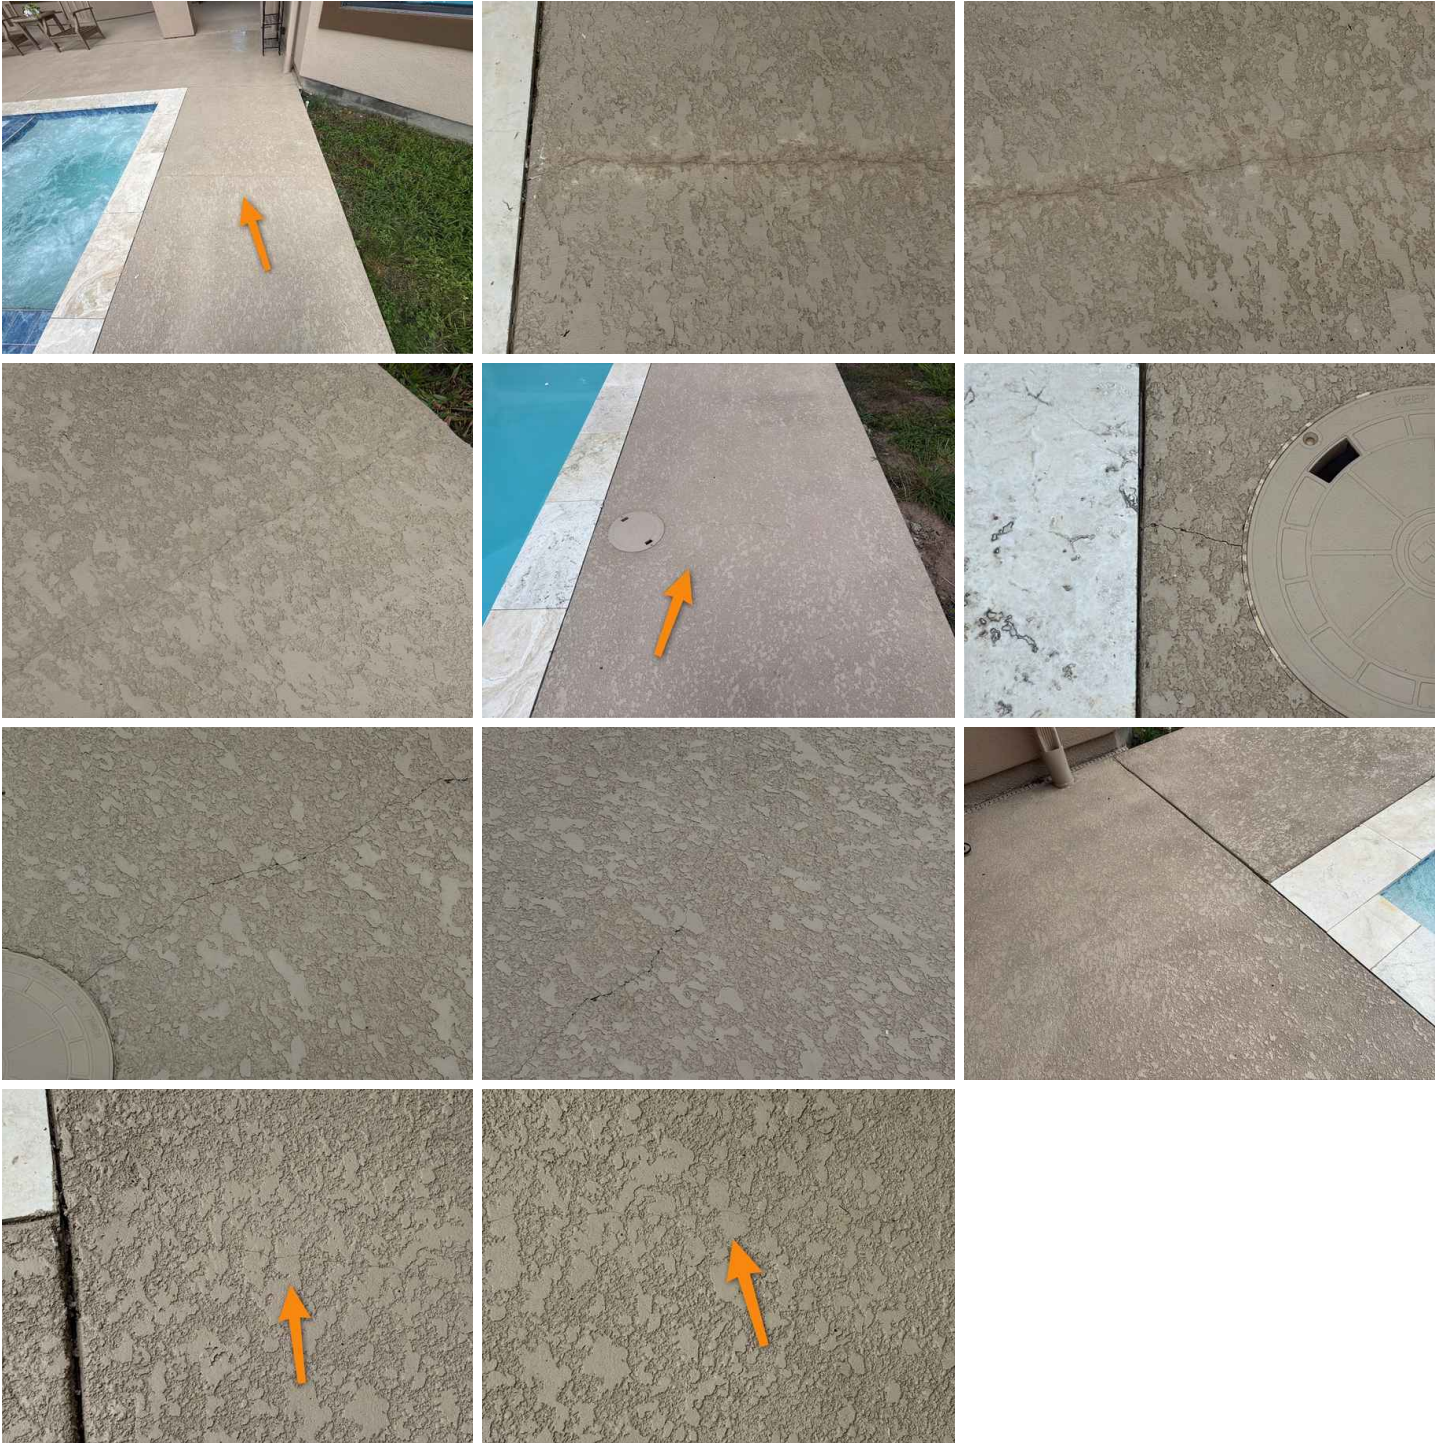
1.2.2 Pool Area Coping, Tile and Decking:

**CRACKED POOL DECKING**

Cracks were observed in the pool decking during inspection. These cracks can allow water infiltration beneath the surface, potentially compromising the structural integrity of the deck and creating trip hazards for swimmers and guests. A pool contractor should evaluate the extent and depth of the cracks to determine if repairs, resurfacing, or replacement is necessary.

Recommendation  
Contact a qualified swimming pool contractor

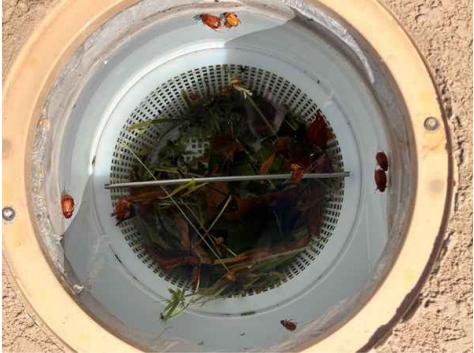
1.7.1 Filtering/Cleaning Type:

**DEBRIS IN SKIMMER BASKET**

Poolside skimmer(s) were observed to contain a significant amount of debris in the skimmer basket. This condition may impede optimal skimming efficiency. To ensure proper functionality, it is recommended to routinely clean the skimmer basket to prevent obstruction and maintain the effectiveness of the skimming process. Regular maintenance in accordance with the manufacturer's guidelines is advised to uphold the pool's overall performance.

Recommendation

Contact a qualified swimming pool contractor
