## T.R.E.C. STANDARD HOME INSPECTION REPORT

1234 Main Street  
Houston TX 77068

07/02/2026 9:00AM

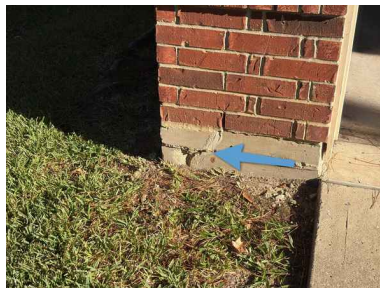
Front Left Corner

One or more of the foundation perimeter beam corners were observed to be either cracked, or sheared off (corner pop). This is a common condition in slab on grade foundations. This condition does not adversely affect the performance of the foundation. However, in some cases, some cosmetic improvements may be necessary

Recommendation: Contact a qualified professional.

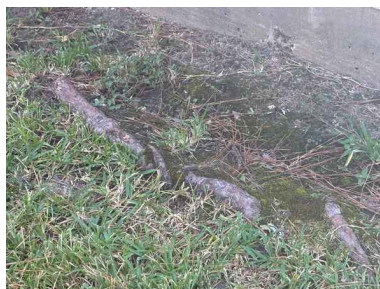
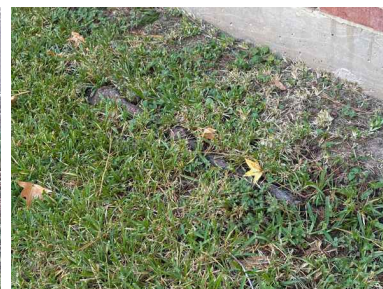
Left Side

Roots were observed near foundation wall. Unable to determine if the roots have any effect on the home. Recommend monitoring.

Recommendation: Contact a qualified professional.

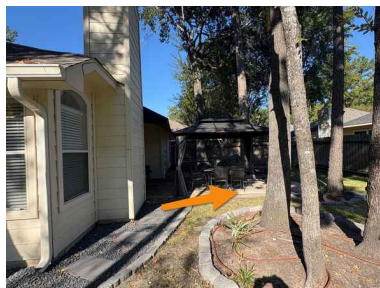
Rear Of Home

Observed tree roots within 10 feet of the home. Unable to determine if the root system have any affect on the homes foundation.

Recommendation: Contact a qualified professional.

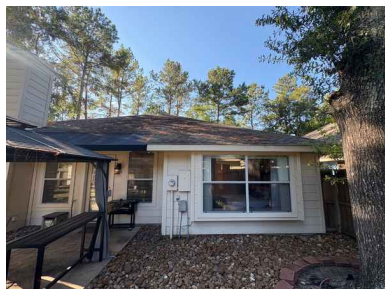
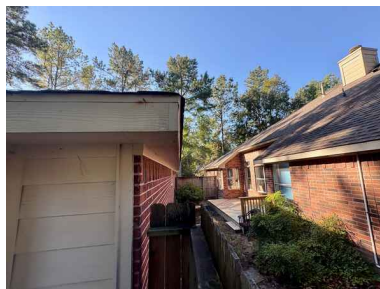
*Recommend Gutters:* Left Side, Rear

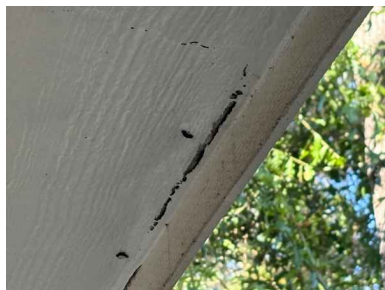
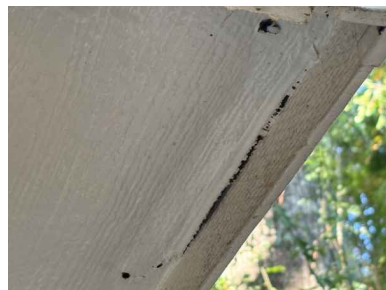
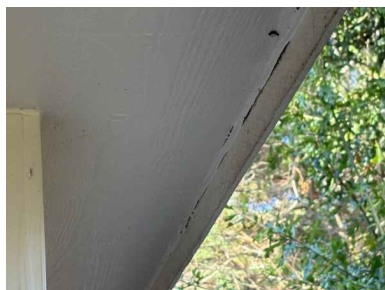
## 2: Openings on Trim

driven rain from coming into contact with unpainted portions of the wood.

Recommendation: Contact a handyman or DIY project

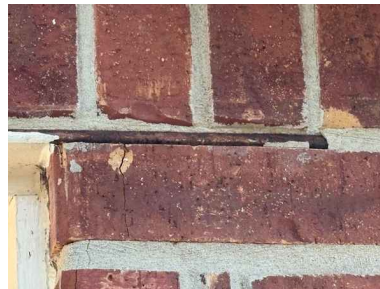
## 2: Lintel over garage door is in need of sealing

There is some movement in this area which is to be expected over an opening like a garage door. We recommend that you monitor this area for sagging in the future.

Recommendation: Recommend monitoring.

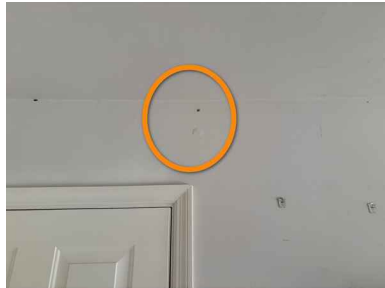
Garage

## 3: Nail pops

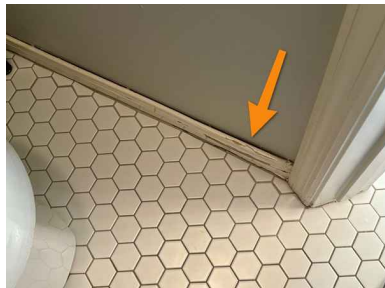
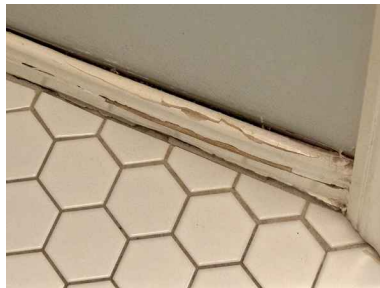
Primary Bedroom Bathroom

The base board has moisture damage and is deteriorated. This area of the wall should be repaired and monitored for further moisture intrusion.

Recommendation: Contact a qualified professional.

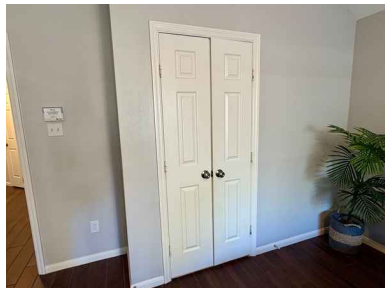
Door doesn't latch properly. We Recommend [repair](#) latch or strike plate.

Recommendation: Contact a qualified handyman.

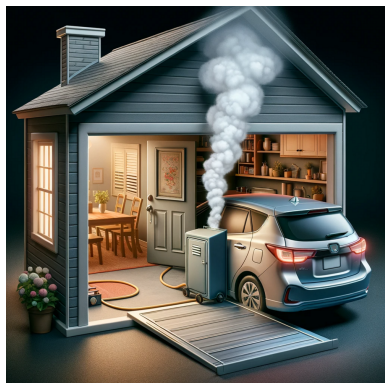
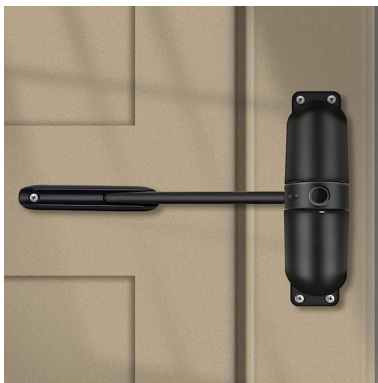
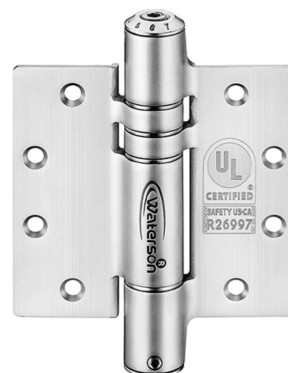
Illustration

Garage service door is missing self-closing hinges, which is a safety concern as it may not close securely on its own. To comply with safety standards, it is recommended to install self-closing hinges to ensure that the door closes automatically after use, reducing the risk of unauthorized access and maintaining security.

Recommendation: Contact a handyman or DIY project

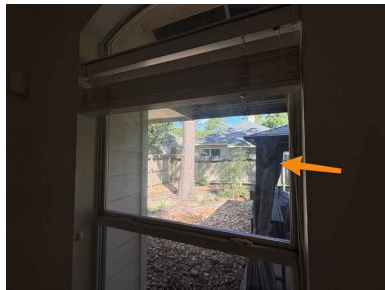
Living Room

Observed condensation and/or fogging between the window panes, which indicates a failed seal. Recommend qualified window contractor evaluate & replace.

Recommendation: Contact a qualified window repair/installation contractor.

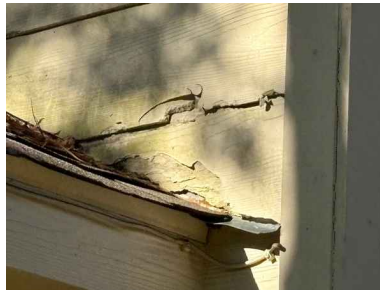
The chimney siding shows visible damage, including cracked and missing sections, which appear consistent with storm-related impact, such as high winds or flying debris. This damage may compromise the chimney's weather resistance, potentially allowing water infiltration and further deterioration if not promptly repaired.

Recommendation: Contact a qualified chimney contractor.

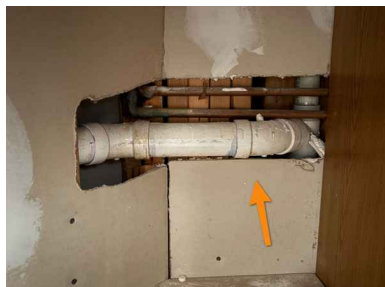
The deck of the cabinet is in need of patching where the plumbing comes through the wall.

Recommendation: Contact a qualified professional.

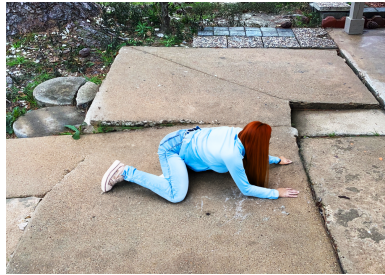
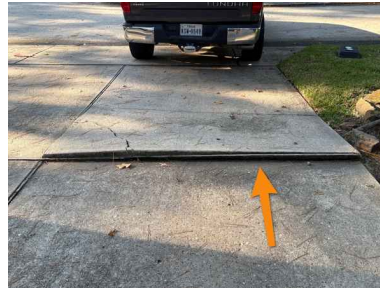
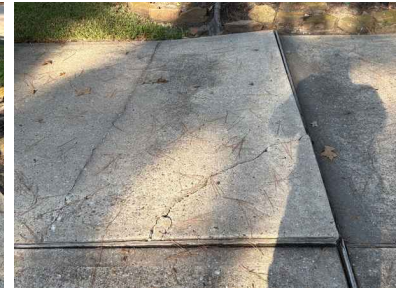
Trip Hazard (Illustration)

The sidewalk/driveway has settled causing uneven joints. This is a potential tripping hazard. Repairs to the sidewalk/driveway are recommended for safety purposes.

Recommendation: Contact a qualified professional.

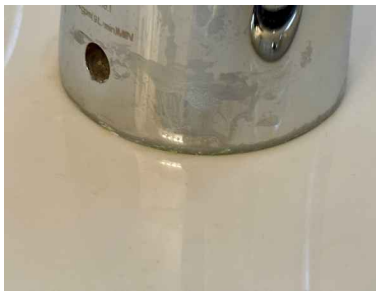
The caulking around the sink(s) is/are in need of repair

Recommendation: Contact a handyman or DIY project

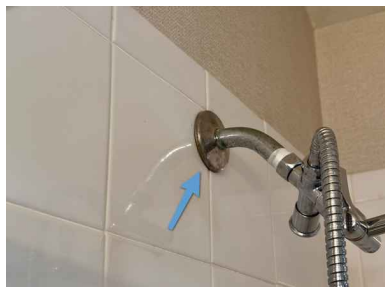
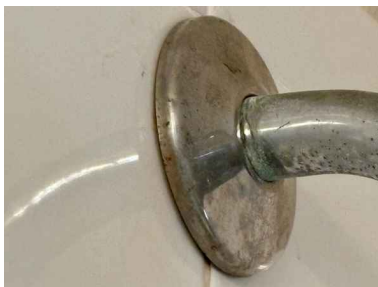
### 3: Showerhead needs caulking at wall

Observed caulking to be deteriorated or and or missing at the shower wall and showerhead flange.

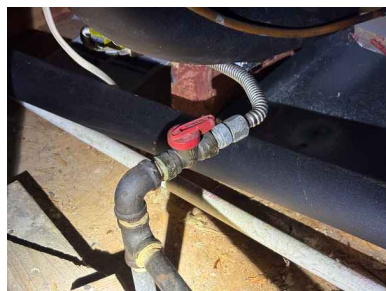
**I=Inspected****NI=Not Inspected****NP=Not Present****D=Deficient****I   NI   NP   D****1: Galvanized Gas Pipe** **Recommendation**

Galvanized piping should not be used for gas because of the galvanized coating. Over time pieces of the galvanized steel will flake off and clog your gas regulators and burner units. Never mix galvanized and black iron or where they touch corrosion will be accelerated.

Recommendation: Contact a qualified professional.

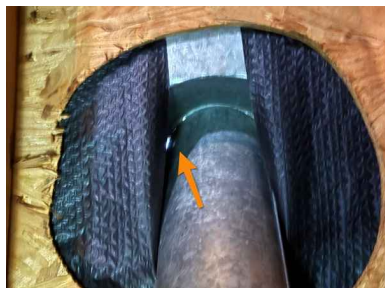
## 2: Vent pipe not connected

Observed a vent pipe from the attic space to be not connected; recommend further evaluation, and any necessary repairs be made.

Recommendation: Contact a qualified HVAC professional.

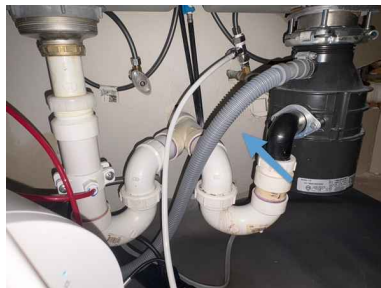
#### 1: Highloop needed

Missing high loop is a common defect found in plumbing systems, particularly in kitchen sinks and dishwashers. A high loop is a section of the drain pipe that is elevated above the sink or appliance, creating a barrier that prevents wastewater from flowing back into the clean water supply. This is an important safety feature that helps to prevent contamination of the water supply with harmful bacteria and other contaminants.

Recommendation: Contact a handyman or DIY project
